SERVICE BULLETIN NO. MSB-AE50R-003

Engine affected: **AE50R Series**

Sub Assembly Rotor & Pulley – R1A-91-100-000 (E_R1 B 034)

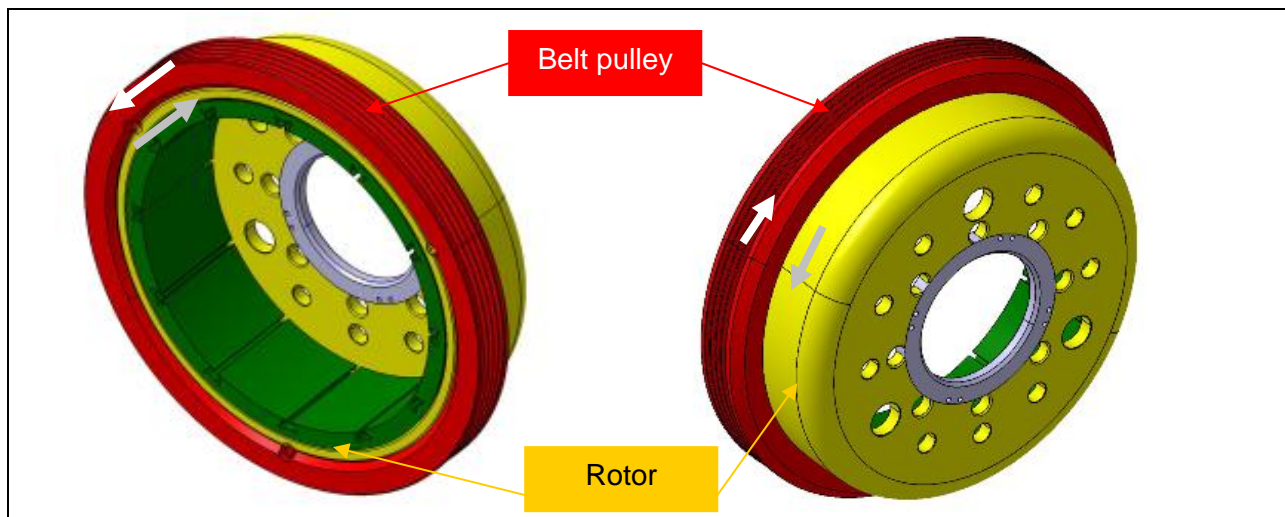
Fixation of the grub screws in the generator rotor assembly and identification of possible relative movement between the belt pulley and the rotor.

The belt pulley is press-fitted and glued on the rotor. Engines beginning with S/N 0497 are secured with grub screws additionally.

During scheduled maintenance on some engines without grub screws relative movement between belt pulley and rotor was identified. In addition some grub screws came loose on engines with grub screws installed.

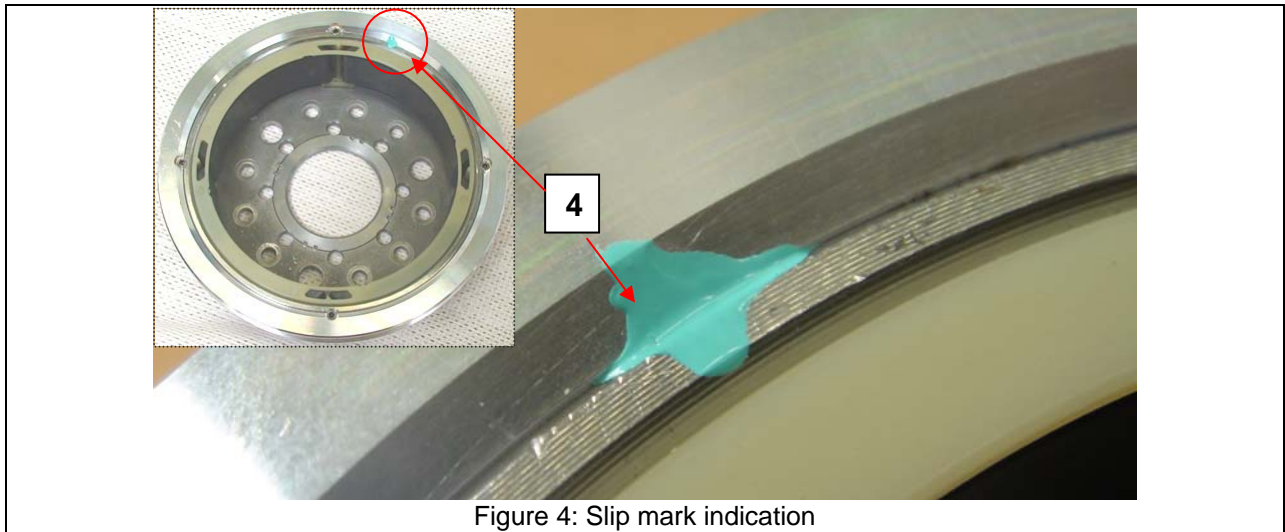
Figure 4: Slip mark indication

- ⇒ Identify if a twist between the belt pulley and the rotor is verifiable evident.
- ⇒ If no movement has been identified apply an adequate slip mark [Figure 4] on the visible belt pulley and rotor surface to monitor possible movement during operation.

It is required to monitor the slip mark during scheduled maintenance to identify possible movement between the belt pulley and the rotor.

If movement has been identified the engine needs to be disassembled and sent back to Diamond Aircraft GmbH (Diamond Engines) for replacement of the parts.
