Mandatory Service Bulletin
No. MSB-E4-009/2

MANDATORY SERVICE BULLETIN

High Pressure Pump exchange.

Type: E4 Engine

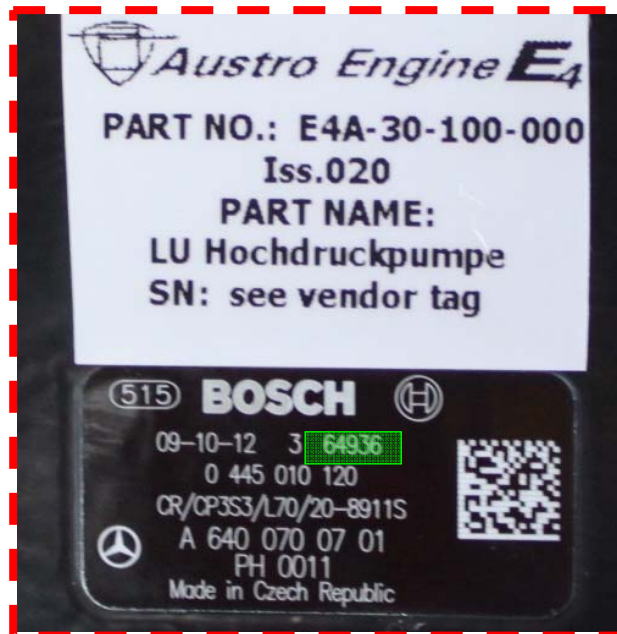
HPP E4A-30-100-000
 to be **exchanged**
