# SERVICE BULLETIN

No. MSB-E4-022/4 SUPERSEDES MSB-E4-022/3

Waste Gate Control Rod.

Engine type: E4

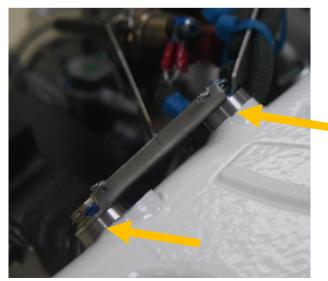
Figure 4: Waste Gate Circlip

Waste gate control rods with insufficient fatigue life have been identified. Failure of the waste gate control rod will lead to a partial loss of power.

- 1. Make sure MM-TR-MDC-E4-386 and MM-TR-MDC-E4-399 are inserted into the Maintenance Manual or a revision of the Maintenance Manual with the Temporary Revisions incorporated is used.
- 2. Replace the waste gate controller according to Maintenance Manual section 81-00-33.
- 3. Install a new the spring loaded circlip E4A-41-100-801. Refer to figure 4

- 1. Replace the waste gate controller according to Maintenance Manual section 81-00-
- 2. Install a new the spring loaded circlip E4A-41-100-801. Refer to figure 4.

- 1. Make sure MM-TR-MDC-E4-422 is inserted into the Maintenance Manual or a revision of the Maintenance Manual with the Temporary Revisions incorporated is used.
- 2. If not yet installed, install a new spring loaded circlip E4A-41-100-801. Refer to figure 4.
- 3. Install the waste-gate con-rod fail-safe bridge according to Maintenance Manual section 81-00-36 or install a waste-gate controller with the fail-safe con-rod bridge already installed. Make sure there is sufficient clearance to adjacent parts.
