SERVICE INFORMATION

No. SI-E4-004

EECU venting element

Type: E4, all models

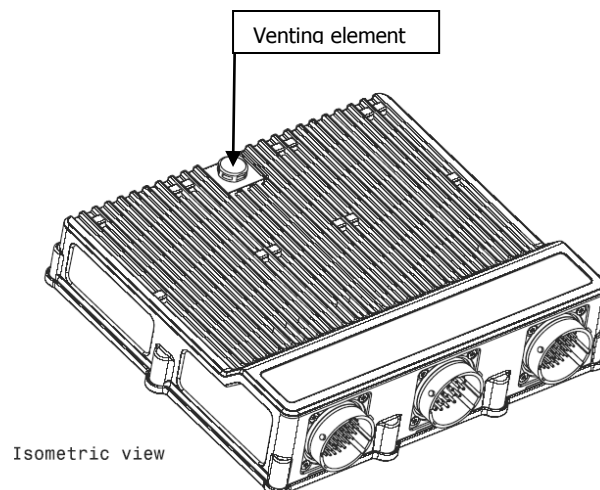
Engine behavior due to clogged venting element of EECU.

During all time it has to be ensured that the venting element of the EECU (see figure below for position of the venting element) is not blocked and that no stagnant water can form above the venting element.
