MSB Service Bulletin
No. MSB-E4-007/6

MANDATORY SERVICE BULLETIN

No. MSB-E4-007/6
SUPERSEDES DOC. No. MSB-E4-007/5

Replacement of Waste Gate Controller

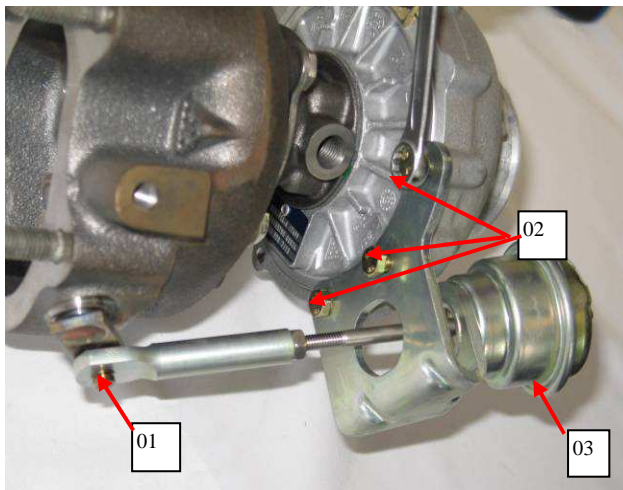
There have been cases where the rod of the Waste Gate Controller cracked. Therefore replacement with latest Waste Gate Controller design is necessary.

1. Disconnect Hose at the top of the Waste Gate Controller
2. Remove three M6 Bolts [02]
3. Remove Circlip [01]
4. Disconnect rod from waste gate lever and remove waste gate controller [03]

Install new Waste Gate Controller according to table section 3.1.
