# MANDATORY SERVICE BULLETIN

## MSB 40NG-046/1

Type: DA 40 NG

Inspection of turbocharger V-clamp.

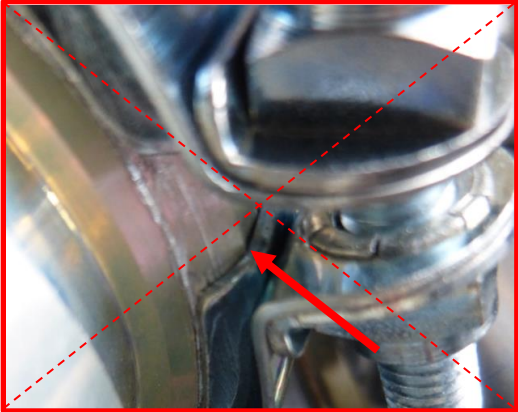
1	Make sure AMM-TR-MÄM-40-853/b is incorporated into the AMM.
2	Make sure the airplane is safe.
3	Remove the cowling i.a.w. AMM Section 71-10.
4	<p>Inspect the V-clamp on the pressure side of the turbo-charger:</p> <ul style="list-style-type: none"> <li>Inspect for positive clearance between the flanges of the turbocharger/aluminium charged air tube and the base of the V-clamp on the complete circumference. If there is <b>NO</b> positive clearance (refer to Figure 1) replace the V-clamp i.a.w. Section III.2. Refer to Figures 1 and 2.</li> </ul> <div data-bbox="295 801 461 1171" style="border: 1px solid red; padding: 5px; margin: 10px 0;"> <p><b>NOT acceptable</b>        (NO positive clearance,        contact to the base)</p> </div> <div data-bbox="710 770 1230 1180" style="border: 1px solid red; margin: 10px 0;">

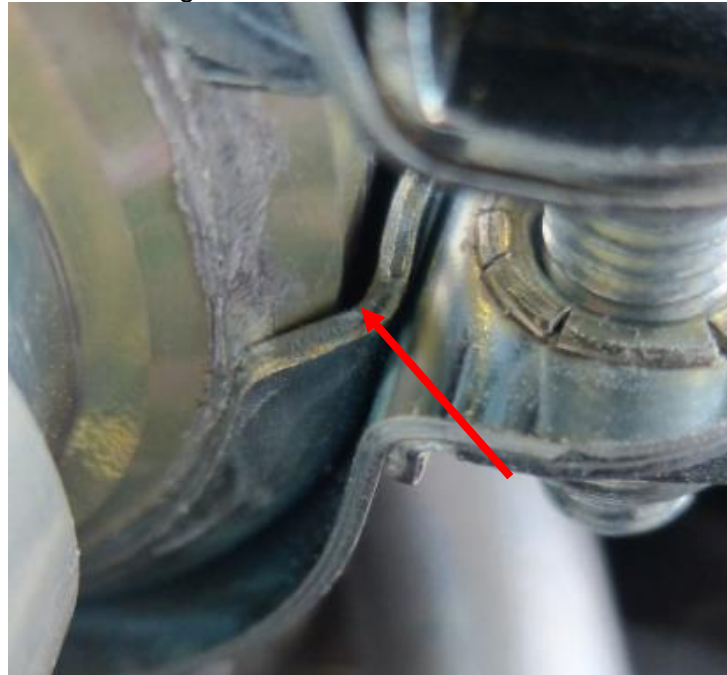
Figure 3

- Inspect for signs of cracks in the edges of the ends of the V-bands of the V-clamp with flashlight and mirror. If signs of cracks are detected, replace the V-clamp i.a.w. Section III.2. Refer to Figure 3.
