Service Information
No. SI-E4-011

Global alternative means of compliance (AMOC) to FAA AD 2018-07-16 (g)

MANDATORY SERVICE BULLETIN

No. MSB-E4-022/5
SUPERSEDES MSB-E4-022/4

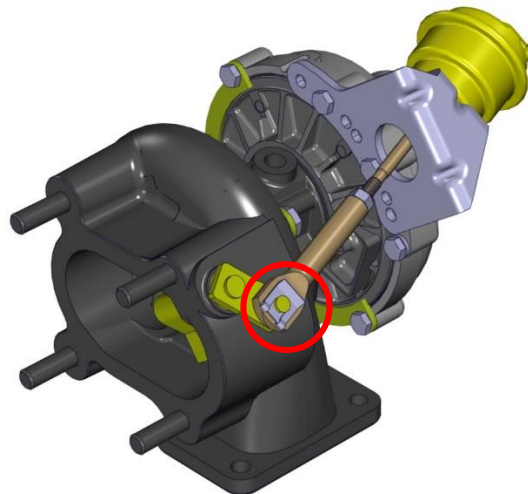
Figure 4: Waste Gate Circlip

Waste gate control rods with insufficient fatigue life have been identified. Failure of the waste gate control rod will lead to a partial loss of power.

1. Make sure MM-TR-MDC-E4-386 and MM-TR-MDC-E4-399 are inserted into the Maintenance Manual or a revision of the Maintenance Manual with the Temporary Revisions incorporated is used.
2. Replace the waste gate controller according to Maintenance Manual section 81-00-33.
3. Install a new the spring loaded circlip E4A-41-100-801. Refer to figure 4

1. Replace the waste gate controller according to Maintenance Manual section 81-00-33.
2. Install a new the spring loaded circlip E4A-41-100-801. Refer to figure 4.
