SERVICE BULLETIN NO. MSB-AE50R-004

Rotor R1A-70-200-000 / R1B-70-200-000

WORK INSTRUCTION

"EXCHANGE OF THE AE50R ROTOR"

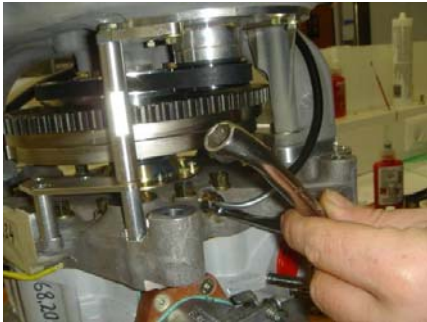
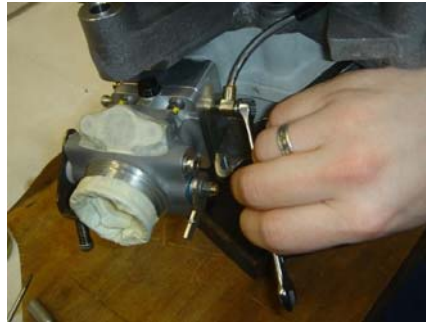
Step 1: Dismounting the oil lines

Release the tightening screws and dismount the oil lines.

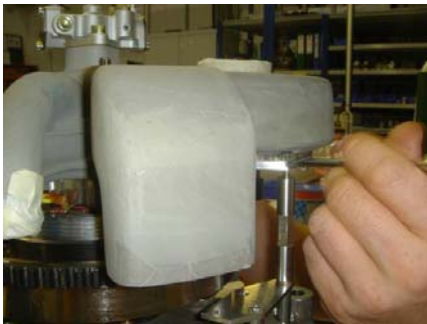
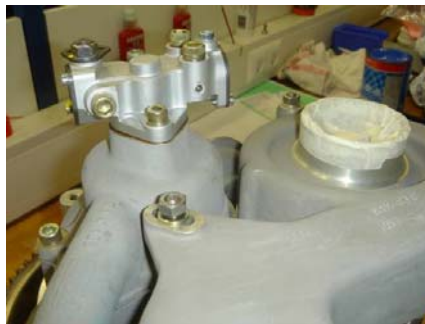
Step 2: Dismounting the fan

Release the screws shown and detach the fan from the engine.
Special attention has to be paid to the position of the shim spacers of the fan studs.

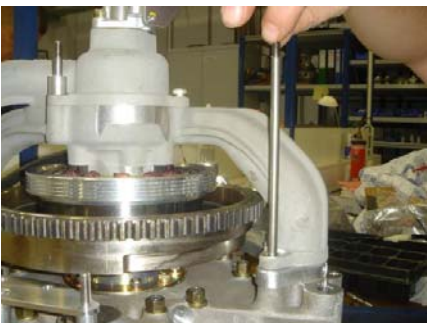
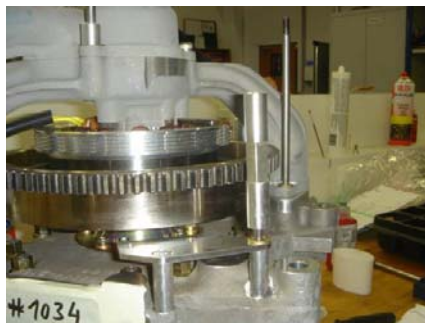
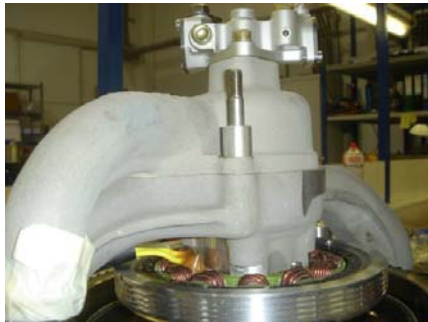
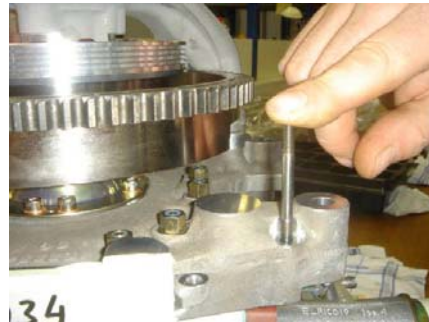
Step 3: Dismounting the fan attachment points and spacers

Dismount the studs and spacers as shown below.
Attention: all studs are Loctite secured.

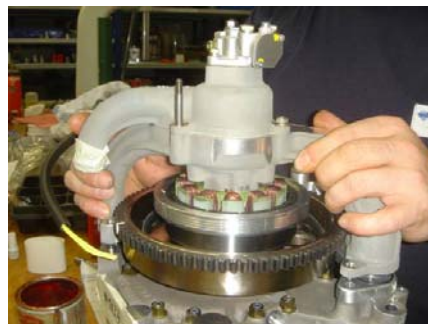
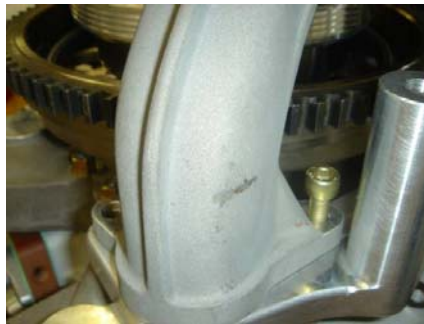
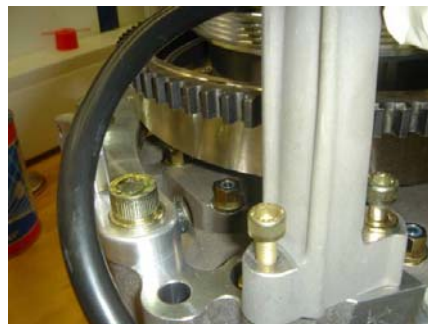
Step 4: Dismounting the water pump

Release the shown screws and remove the water pump from the engine. Special attention has to be paid to the centre bolts.

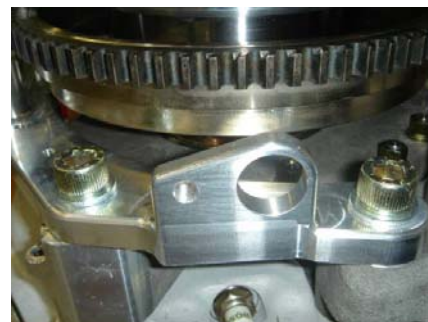
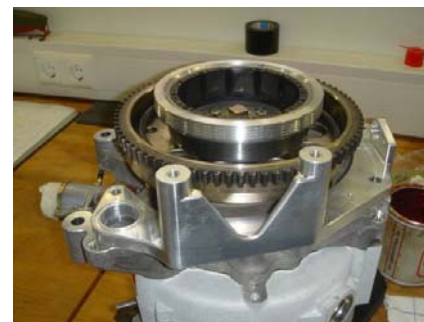
Step 5: Dismounting the starter plate

Release the shown screws and remove the starter plate from the engine.

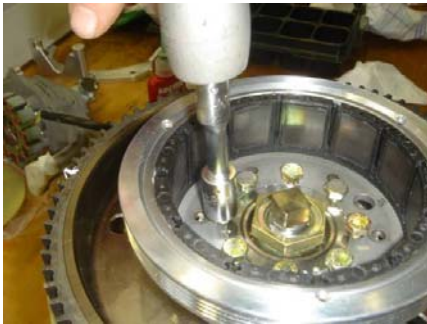
Step 6: Dismounting the generator

Release the screws shown and remove the generator from the flywheel.
Attention: all screws are Loctite secured.

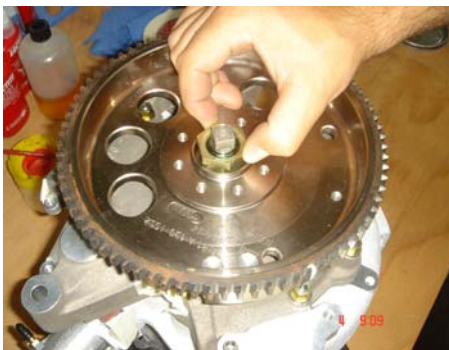
Step 7: Dismounting the flywheel

Release the main nut and remove the flywheel from the eccentric shaft. There is a special tool required for this action, so please contact Austro Engine for purchasing the tool.

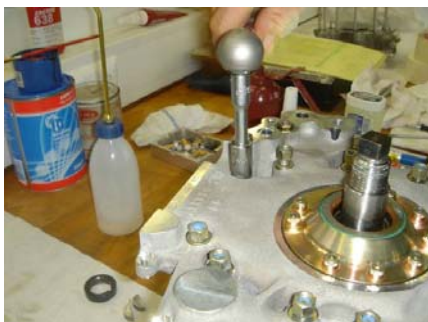
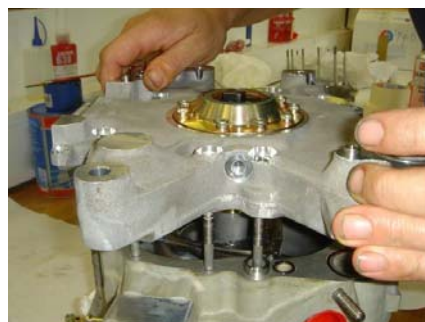
Step 8: Dismounting the backplate

Remove the oilseal-ring and the woodruff key.
Release the nuts shown and remove the backplate with caution.

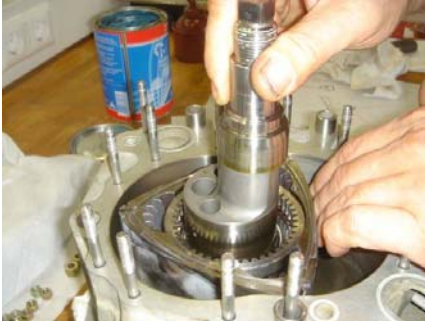
Step 9: Removing the eccentric shaft

Mark the rotor and the sealing parts and dismantle the sealings clockwise. The rotor has to be adjusted to the correct position to make it possible to remove the eccentric shaft. Take out the eccentric shaft with caution as shown.

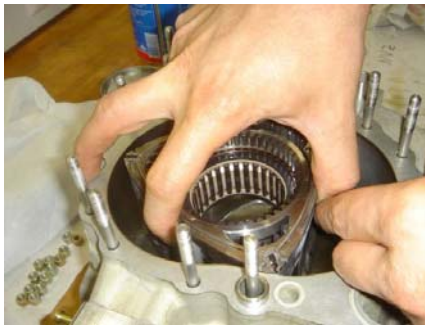
Step 10: Removing the rotor

Pick up the rotor as shown and take it out of the trochoid slowly. Take caution as some of the rotor sealings are likely to fall off the rotor during this process.

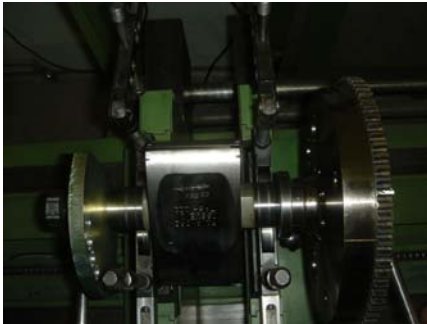
Take the new rotor part no. R1A-70-200-000-010 and assemble it with the cleaned parts to a balancing group.

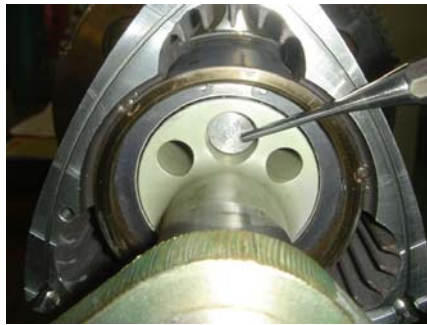
Insert the compensation weight of the sealings into the eccentric shaft.

Perform a balancing of the whole group on a balancing machine pt. no. MWT 059/1 until a sufficient balancing is reached.

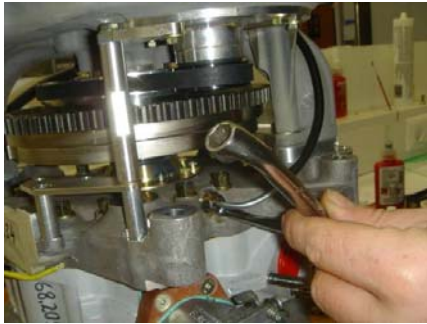
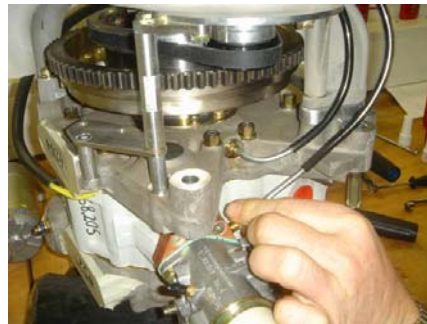
Step 1: Dismounting the oil lines

Release the tightening screws and dismount the oil lines.

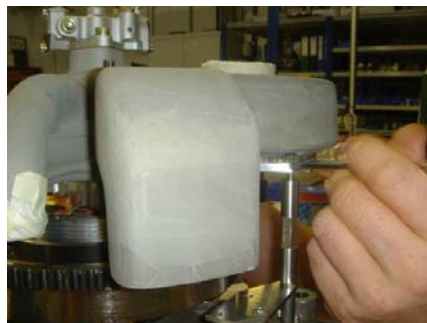
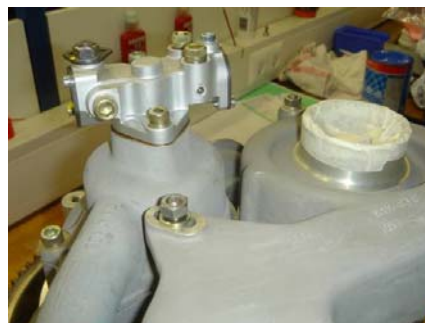
Step 2: Dismounting the fan

Release the screws shown and detach the fan from the engine.
Special attention has to be paid to the position of the shim spacers of the fan studs.

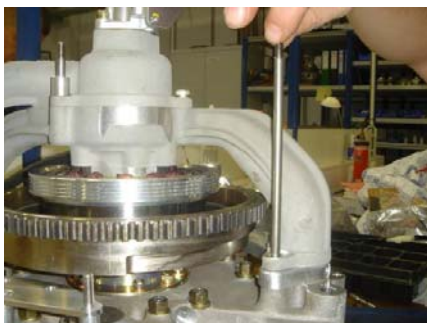
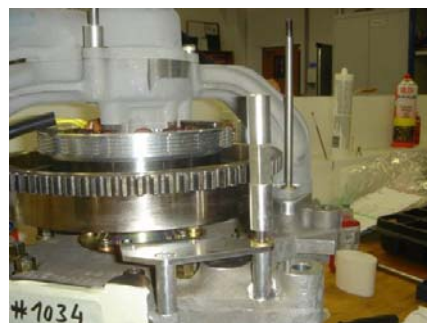
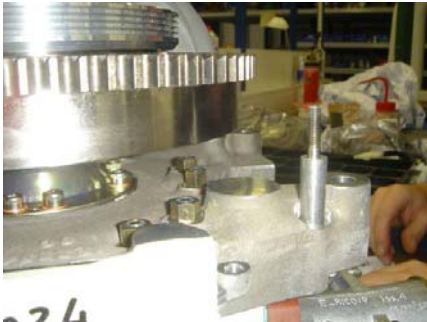
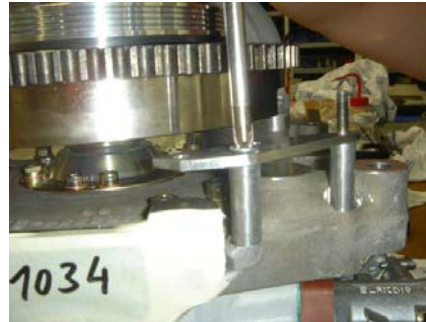
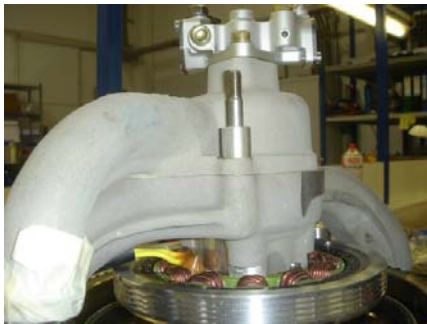
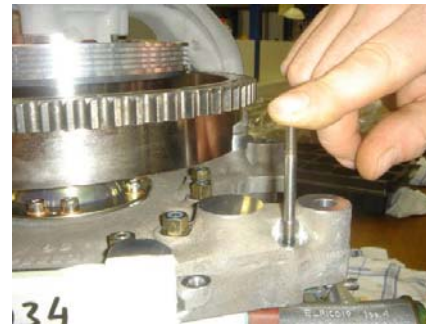
Step 3: Dismounting the fan attachment points and spacers

Dismount the studs and spacers as shown below.
Attention: all studs are Loctite secured.

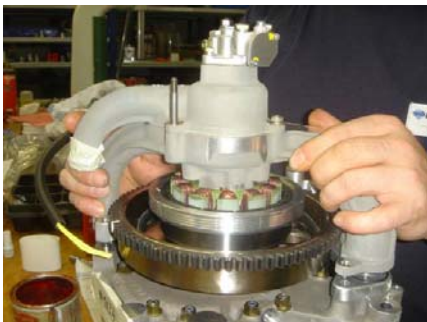
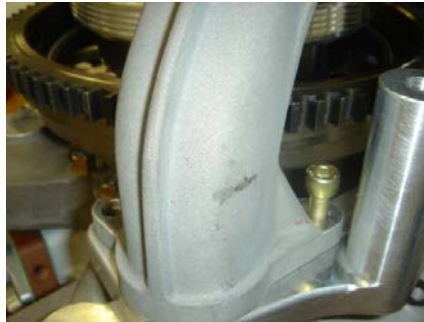
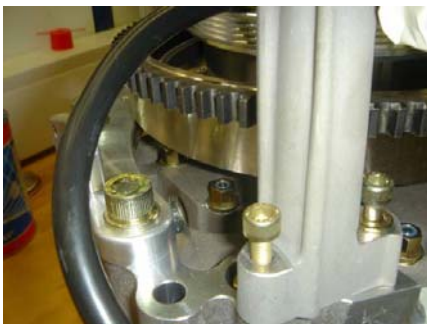
Step 4: Dismounting the water pump

Release the shown screws and remove the water pump from the engine. Special attention has to be paid to the centre bolts.

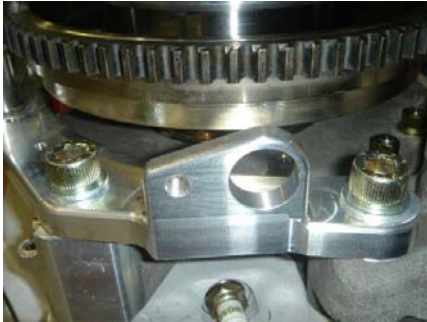
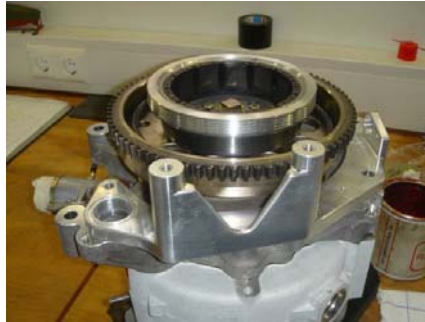
Step 5: Dismounting the starter plate

Release the shown screws and remove the starter plate from the engine.

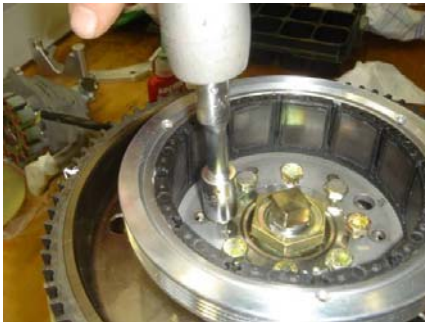
Step 6: Dismounting the generator

Release the screws shown and remove the generator from the flywheel.
Attention: all screws are Loctite secured.

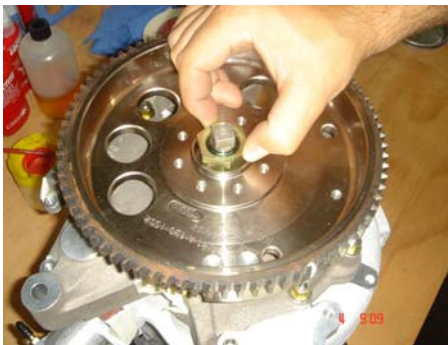
Step 7: Dismounting the flywheel

Release the main nut and remove the flywheel from the eccentric shaft. There is a special tool required for this action, so please contact Austro Engine for purchasing the tool.

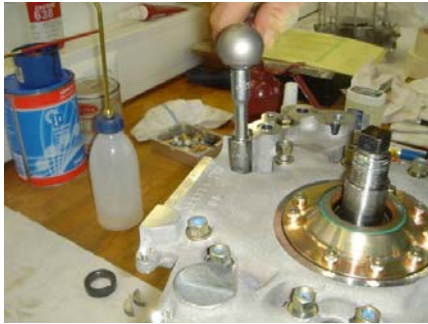
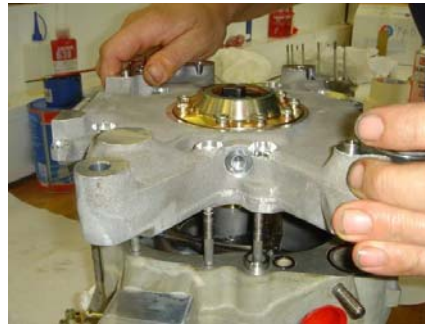
Step 8: Dismounting the backplate

Remove the oilseal-ring and the woodruff key.
Release the nuts shown and remove the backplate with caution.

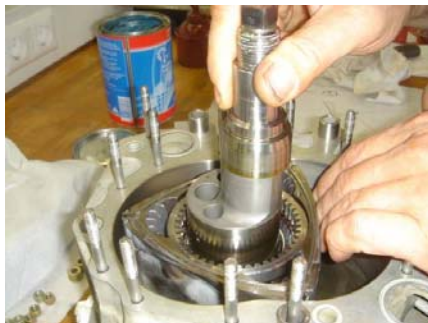
Step 9: Removing the eccentric shaft

Mark the rotor and the sealing parts and dismantle the sealings clockwise. The rotor has to be adjusted to the correct position to make it possible to remove the eccentric shaft.
Take out the eccentric shaft with caution as shown.

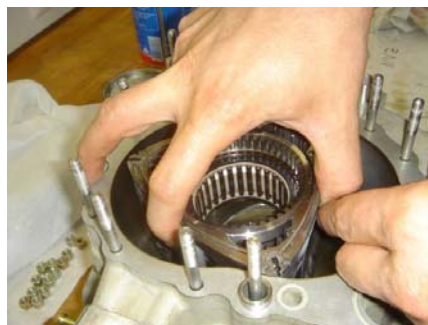
Step 10: Removing the rotor

Pick up the rotor as shown and take it out of the trochoid slowly. Take caution as some of the rotor sealings are likely to fall off the rotor during this process.

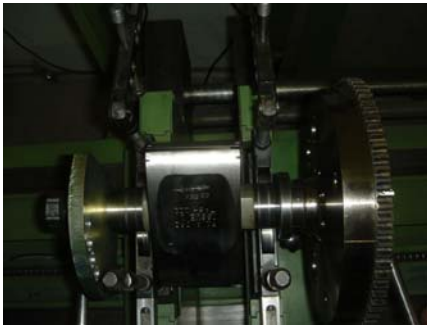
Take the new rotor part no. R1B-70-200-000-010 and assemble it with the cleaned parts to a balancing group.

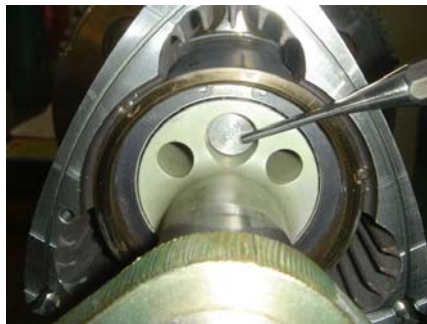
Insert the compensation weight of the sealings into the eccentric shaft.

Perform a balancing of the whole group on a balancing machine pt. no. MWT 059/1 until a sufficient balancing is reached.
