# MANDATORY SERVICE BULLETIN

## No. MSB-E4-030/1 Supersedes MSB-E4-030

Oil pump replacement

Engine affected: E4 Series

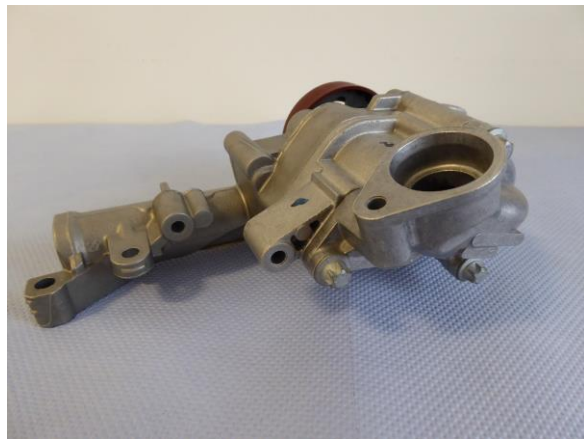
**Fig. 1**

Delivered oil pump

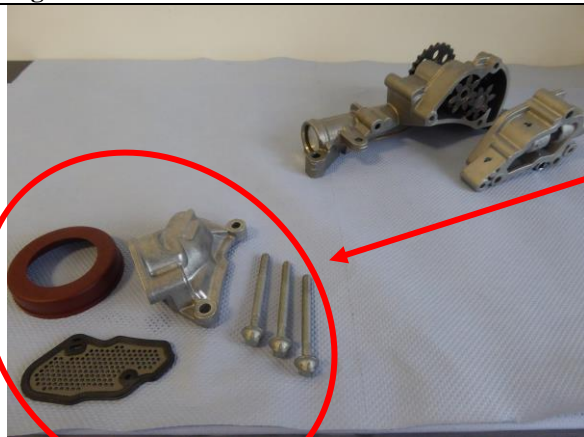
**Fig. 2**

Remove the following parts of the new oil pump:

- Cover of the chain gear
- Original oil suction pipe (including screws and oil strainer)

Note: Discard the removed parts.

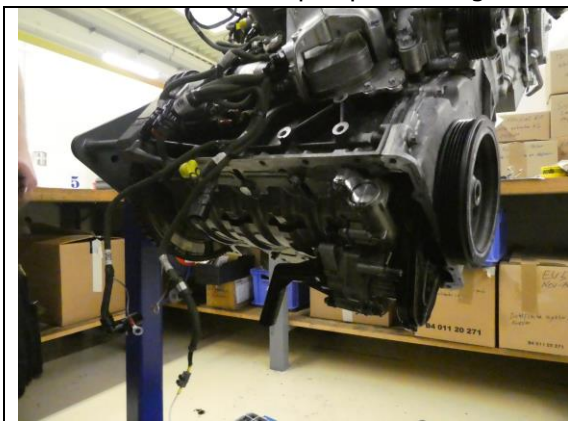
<p><b>Fig. 3</b></p>	<p>After removal of the oil sump</p>

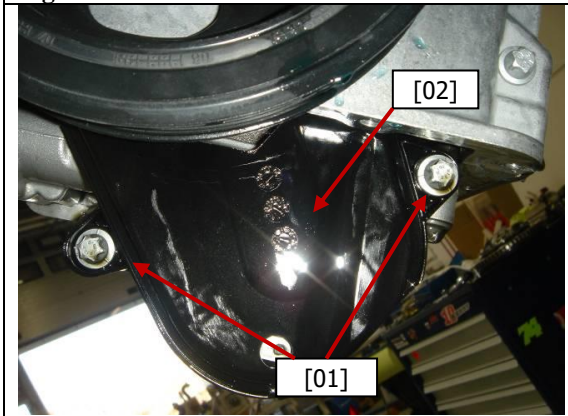
<p><b>Fig. 4</b></p>	<p>Loosen two screws [01] that attach the chain cover [02] to the oil pump and remove the chain cover.</p>

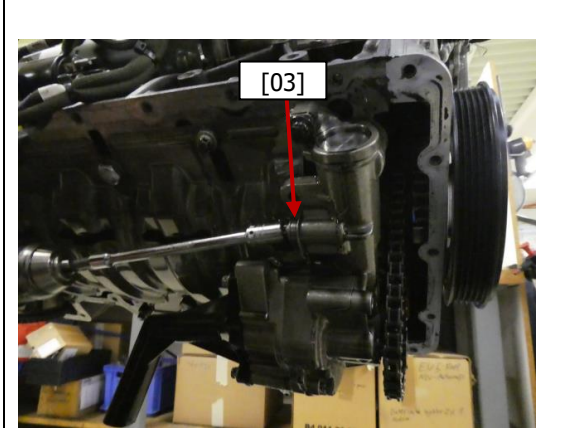
<p><b>Fig. 5</b></p>	<p>Remove the screw [03] that attaches the oil pump to the oil repellent.</p>

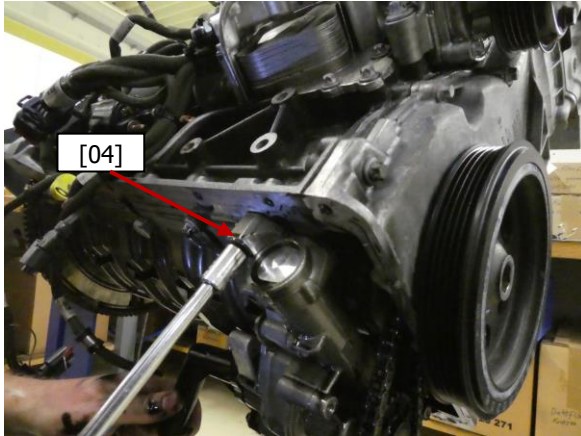
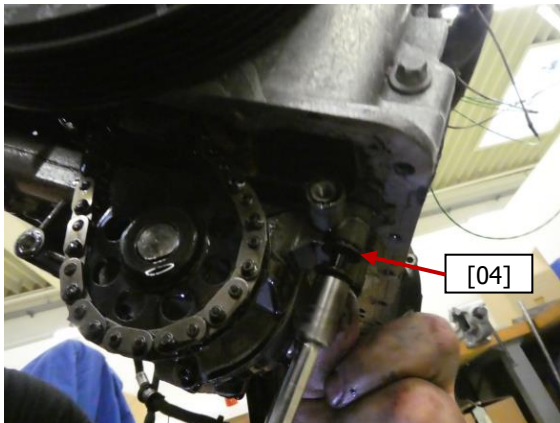
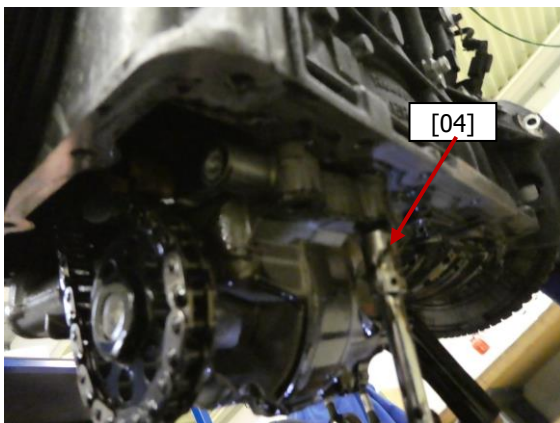
Remove three screws [04] that attach the oil pump to the crankcase.

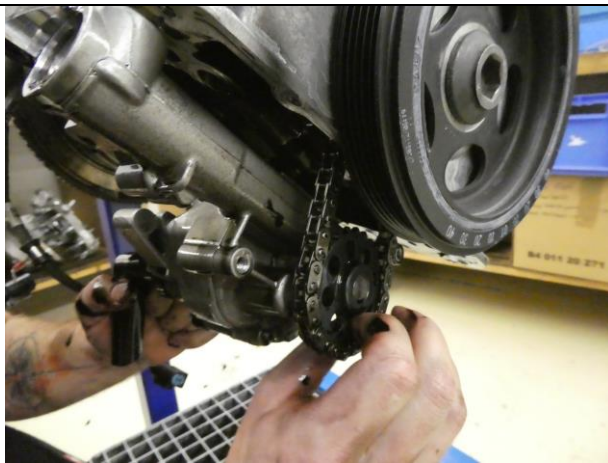
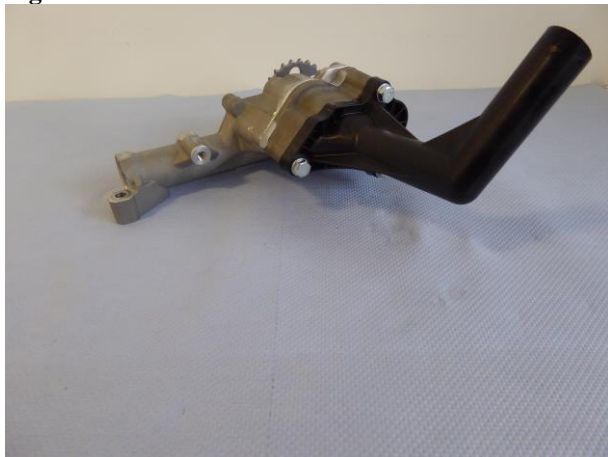
Loosen the oil pump chain gear from the oil pump chain.

Remove the oil pump.

Examine the oil pump for blockage. Make sure that the pump gears move freely when turned by hand.

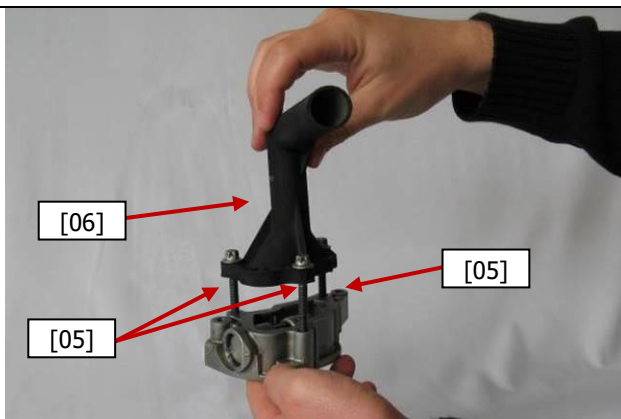
**Fig. 11**

Removed oil pump (E4A-50-000-BHY)

Loosen three screws [05] of the oil pump and remove the oil suction pipe with the integrated oil strainer [06] (E4A-50-100-BHY) from the old oil pump.

Note: The oil suction pipe with oil strainer and the screws [05] must be reused for the new oil pump installation.

After removal of the oil suction pipe, examine the oil pump gears for damage.

**In case of a blocked, and/or partially blocked, and/or damaged oil pump, please contact Austro Engine for further instructions.**

**NOTE:** Removed oil pump must be always returned to Austro Engine, including the engine flight hours recorded at the time of replacement.

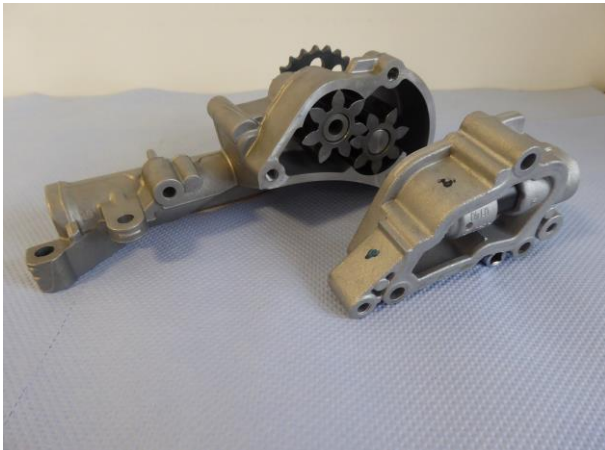
<p>New oil pump</p>

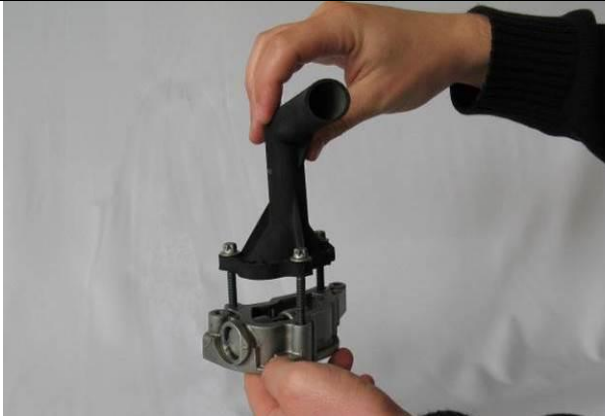
<p><b>Fig. 12</b></p>	<p>Fit the oil suction pipe [06] (E4A-50-100-BHY / re-used from the old oil pump) in place on the valve housing (E4A-50-520-000) and then insert the three hexagon screws [05] (ISO_4014-M6xM60-10.9 with washers ISO_7089-6 / alternative MBN 10 143-M6x63-10.9) through the holes.</p>

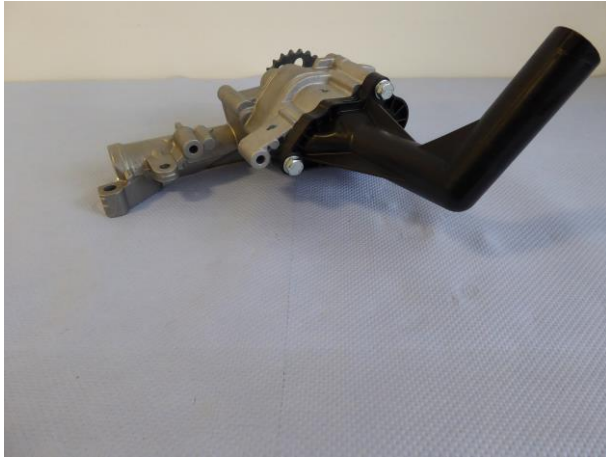
Apply Loctite 278 or Loctite 2701.  
Tighten the oil pump housing with 12 Nm.

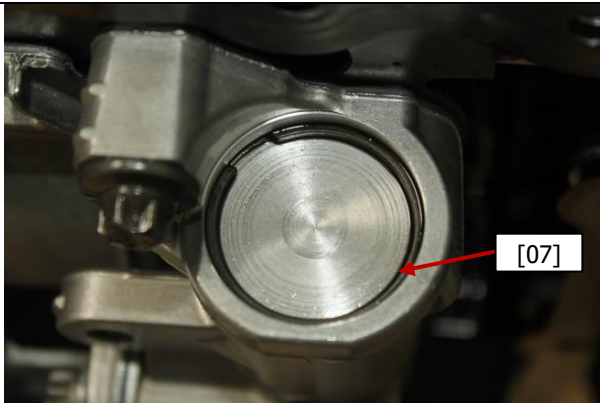
**Fig. 13**

Make sure that the circlips [07] (E4A-50-300-801) [08] (E4A-50-400-801) used to secure both plugs on the oil pump is in the correct position.

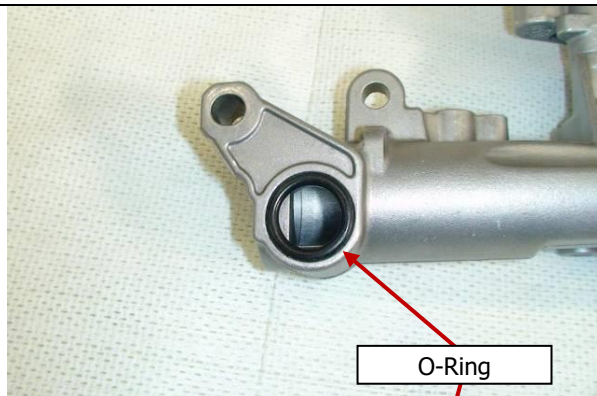
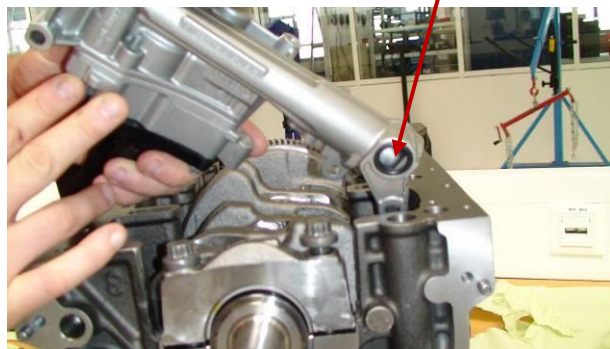
Discard the O-Ring (OR\_16x3-ACM 70) between the oil pump and the crankshaft housing.

Install a new O-Ring.  
 Make sure it is correctly fitted.

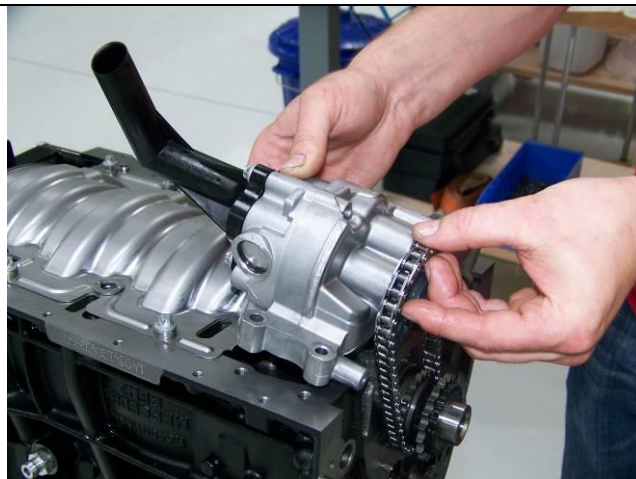
**Fig. 17**

Install the oil pump chain.  
 Apply some approved engine oil (refer to the MM) on the chain before installation.

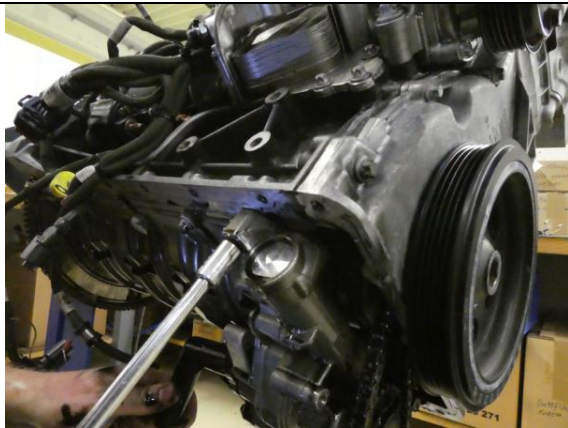
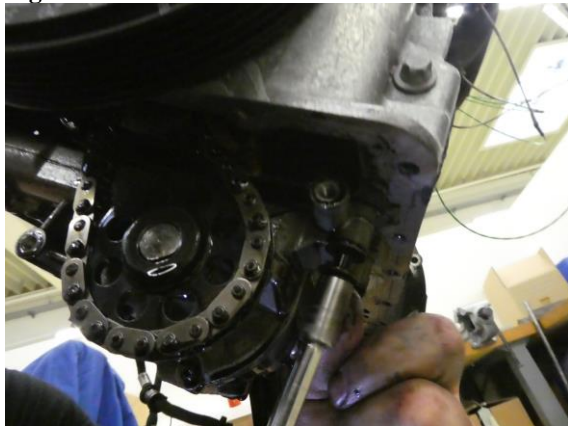
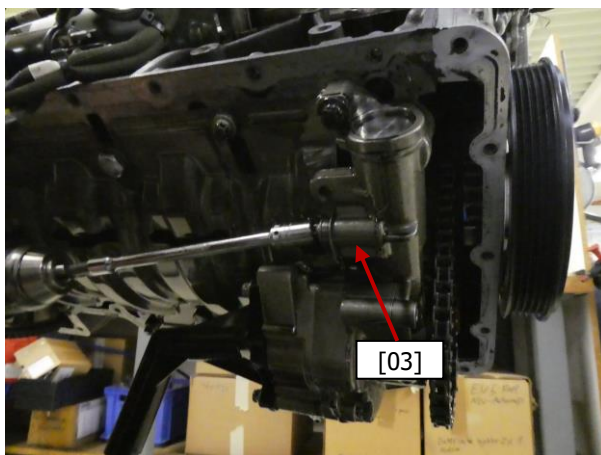
Install the oil pump with O-Ring and three screws [04] (M7x27 – 8.8 – DBL 9400.40) on the crankcase.

Apply Loctite 2701 or 278 on the thread and tighten with a torque of 14 Nm.

Install the screw [03] that attaches the oil pump to the oil repellent. Apply with Loctite 243 and torque it with 12 Nm.

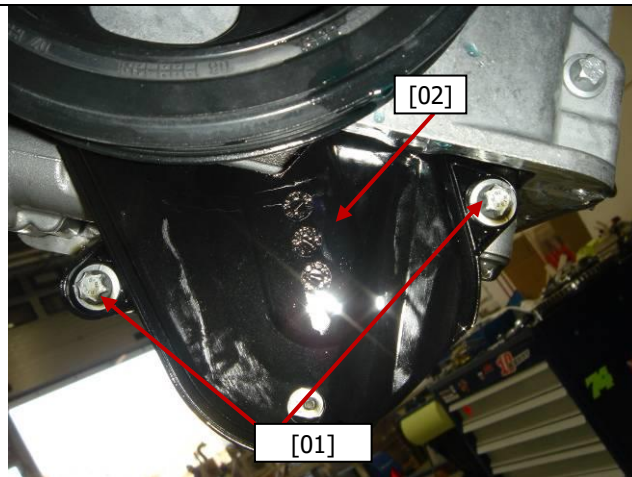
**Fig. 21**

Install the oil pump chain cover

Put the chain cover [02] in place on the oil pump and tighten the screws [01] (ISO8102-M6x20-10.9) (x2) with 12 Nm.
